WATERSHED SURVEY FINAL REPORT & ACTION PLAN

ONOTA LAKE WATERSHED
PITTSFIELD, LANESBOROUGH, AND HANCOCK, MASSACHUSETTS
SPRING 2003

Onota Lake Watershed Survey Final Report

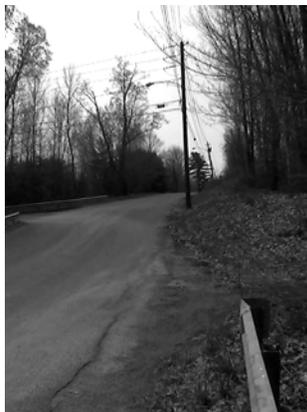
Historical reports from locals indicate the existence of a pig farm along the stream bank of Daniels, north of E at F in the 1940's. No visible evidence remains except rusted pig fence is still in place. Neither stream bank disturbance nor organic discharge is currently apparent.

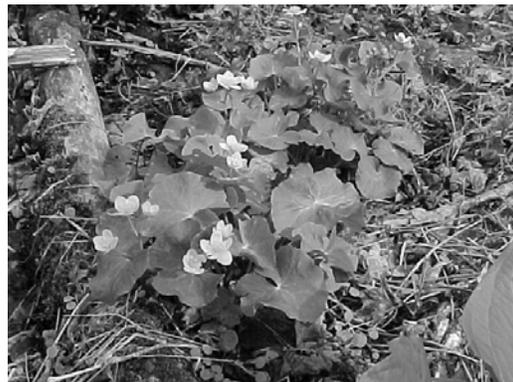
We visually inspected most of the Section 10 area either by car or on foot. The northern half (north of Hancock Rd) is basically the Pontoosuc Golf Course. It appears that the whole area drains to the unnamed stream passing under Hancock Road (10-357, 10-358) and then flows through a beautiful, natural wetland (10-361, 10-362) almost to Pecks Road (10-364, 10-368). There are steep banks on both sides of the wetlands and one area behind a house at the north end of Bromback Street showed signs of erosion (10-363). The

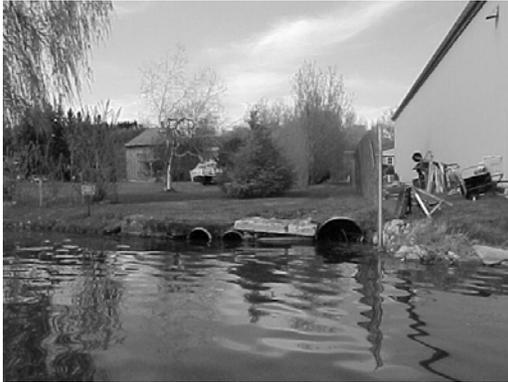
water flowing in the stream thru the wetlands was clear and beautiful. There were a few discarded, rusting metal items on the banks but none appeared to be more than eyesores. No pollution was observed. The stream dissipates into the ground about ¼ mile northeast of Pecks Road (10-367) over a wetland approximately 15 meters wide and 100 meters long. This is the normal condition. However, during spring runoff and/or heavy rain, the water flows all the way to the triple pipe culvert going under Pecks Road (10-371) and on into the lake (10-372).
