LAKE

ONOTA

ANNUAL MONITORING PROGRAM REPORT

2022

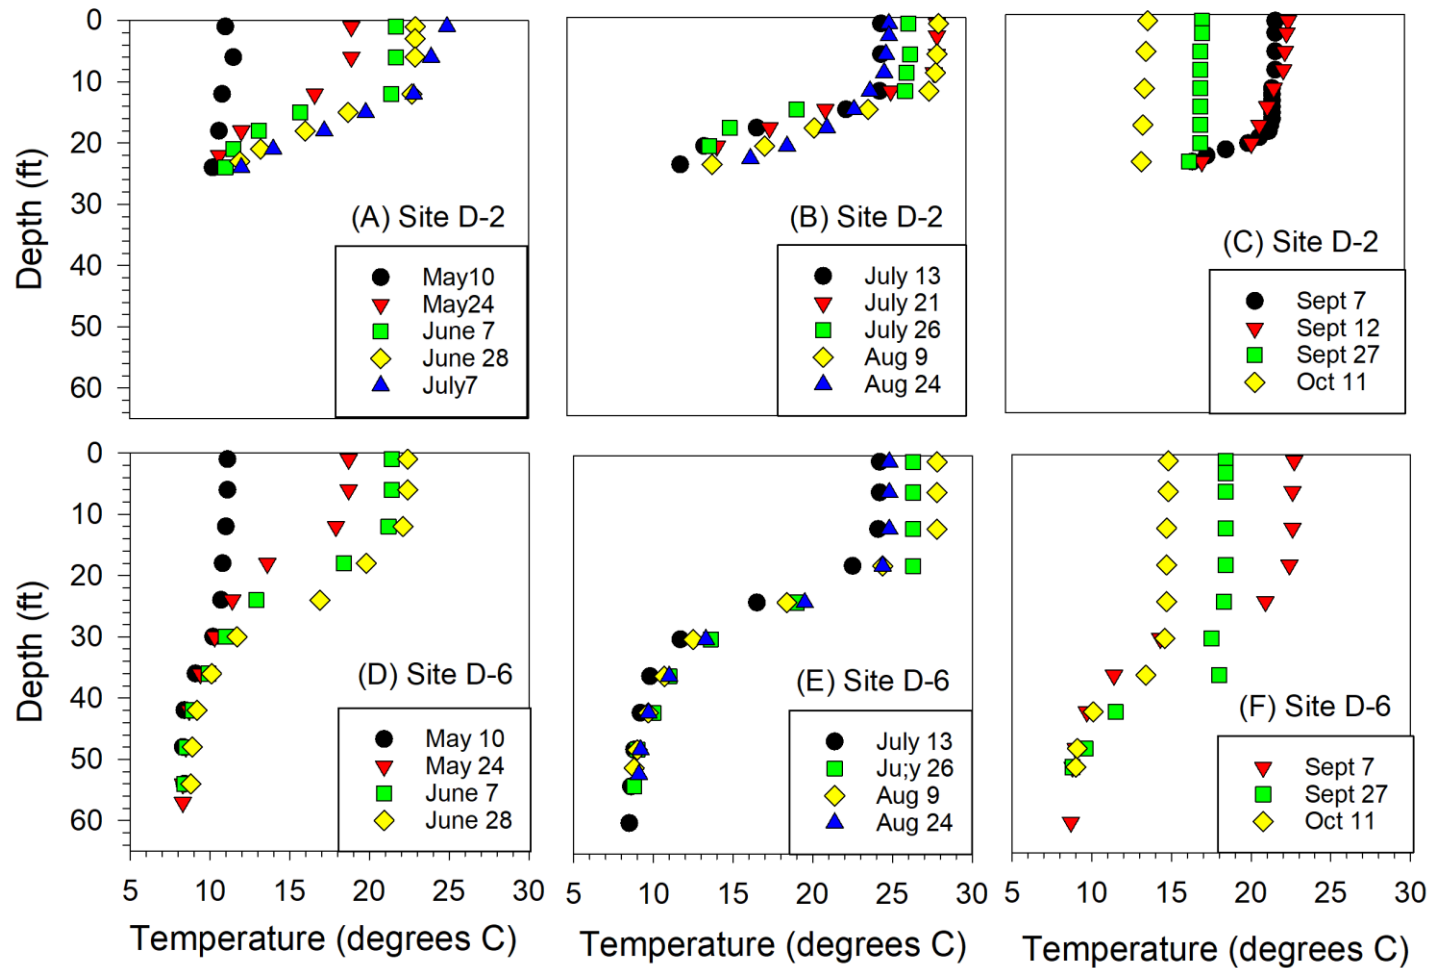
**Figure 2.** Temperature profiles at sites D-2 (north basin) and D-6 (south) in Onota Lake, in 2022. Each site has three plots to cover the entire season: plots A, B, and C show temperature data for site D-2; plots D, E, and F show temperature data for site D-6. Extra dates for site D-2 (July 7, July 21, and Sept 12) are from site visits for cyanobacteria sampling. All data can be found in Tables 3 and 4 (for sites D-2 and D-6, respectively). Note that the same depth scale is used for both sites, even though the maximum depth of site D-2 is only 24-25 feet (Table 3); use of the same scale enhances the ability to compare and contrast the temperature profiles between the two sites.

Thermal stratification started to break up in the north basin (site D-2) by mid-September and the water column was almost completely mixed as of the site visit on October 12 (Figure 2C). In contrast, stratification persisted in the deeper south basin (site D-6) into October (Figure 2F).

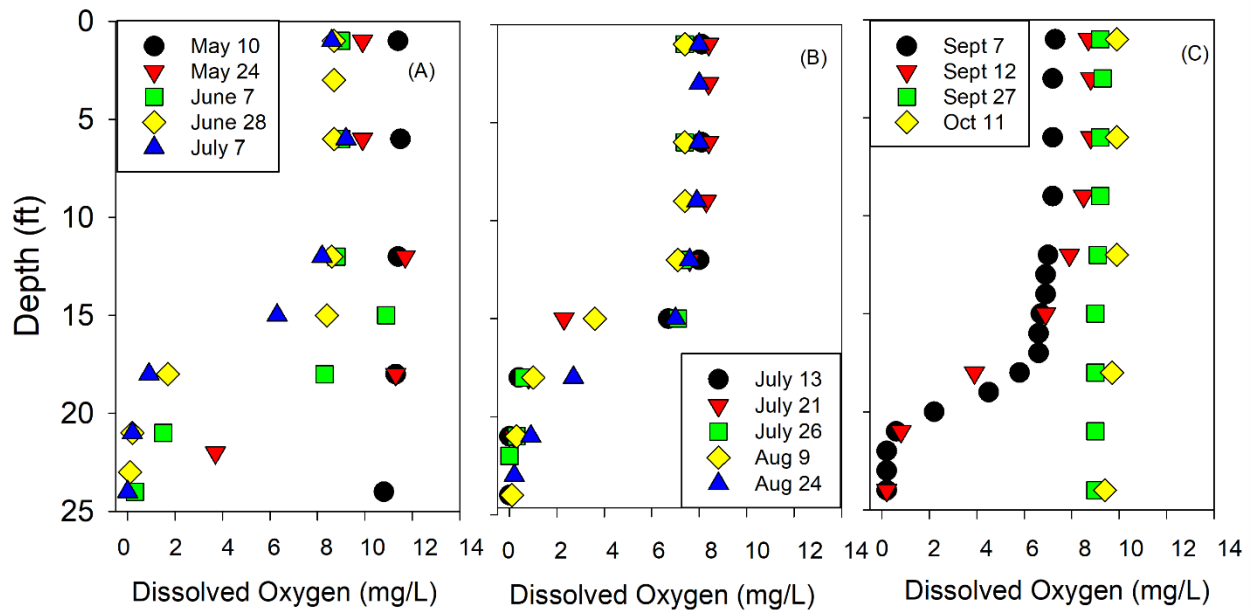
**Figure 3.** Dissolved oxygen profiles of Onota Lake at site D-2, the deepest part of the north basin, in 2022. Each plot shows data from 4-5 site visit dates for the following periods: (A) May 10 – July 7, (B) July 13 – Aug 24, and (C) Sept 7 – Oct 11. Note: the symbols for July 13 at depths 1 and 6 are largely hidden behind the other symbols.

Dissolved oxygen measurements in Onota Lake in 2022 (Tables 3 and 4; Figures 3 and 4) show a typical seasonal pattern of a well-oxygenated water column from top to bottom after spring turnover, followed by loss of D.O. in deeper water of each site through the summer after the lake has stratified. During summer stratification, the deeper waters are isolated from the upper waters, and D.O. that was present in the beginning of the season gradually becomes depleted. Thus, even though the waters at greatest depths at site D-6 can be sufficiently cold for trout and other cold-water fishes (Figure 2, Table 4), the cold-water layer that also contains sufficient D.O. for the entire summer does not extend much (or at all) into the hypolimnion. In 2022, at D-6, the upper 30 feet or so of water maintained D.O. concentrations  $\geq 5$  mg/L until mid-September, when D.O. concentrations at that level dropped slightly below 5 mg/L. After this date the mixing associated with fall turnover delivered more D.O. to greater depths (Figure 4). During stratification in 2022, 'trout water', with both cold temperatures ( $<$  about 19 degrees Celsius or 66 degrees F) and ample D.O. ( $\geq 5$  mg/L), occurred in a layer from about 24 to 30 feet for the entire season at D-6. This layer was thicker in the earlier part of the season and became thinner with the warming of the upper waters and continued D.O. loss from the deeper waters. In contrast, the relatively shallow depth of site D-2 resulted in only the upper 12 feet or so of water having D.O. concentrations  $\geq 5$  mg/L for the full period of summer stratification. (But note D.O. concentrations were  $\geq 5$  mg/L in the upper 15 feet for much of the season). However, this upper layer of water with ample D.O. did not sustain sufficiently cold temperatures through the summer months (Figure 2B) to support resident populations of trout and other cold-water fishes.

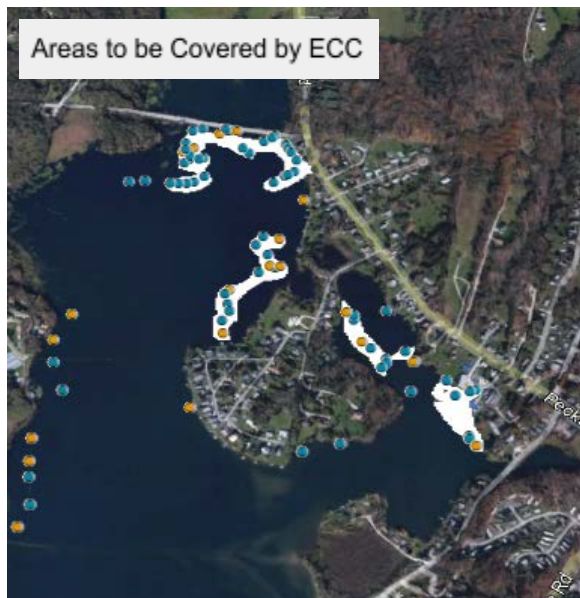
It is difficult to say why this higher than expected regrowth occurred, however SePRO has agreed to cover the materials to re-treat certain areas of regrowth that meet the specification under their Extended Control Contract (ECC), which is in effect through the 2023 growing season. Specifically, SePRO will provide enough ProcellaCOR to re-treat the areas shown in white in the below figure which total 14.5 acres.

These areas only should be treated in 2023 and re-growth should continue to be monitored and evaluated for coverage under the ECC.
